Manhole Inspection Summary

Manhole # S23II1019MH

Location Address: **4246 FALLS RD**

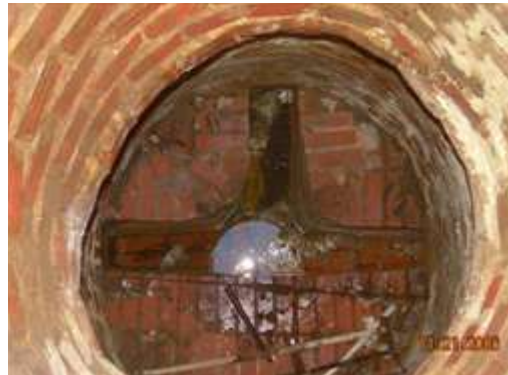
Top View

Barrel infiltration. Evidence of surcharge - Bench debris. Channel debris.

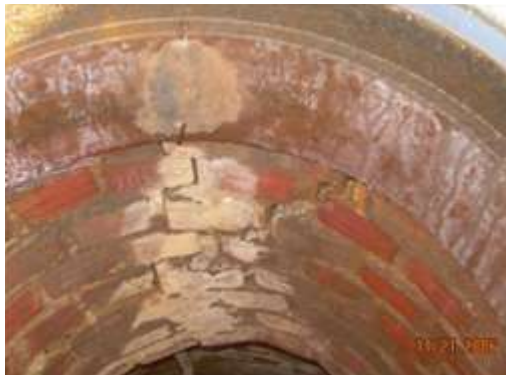
Defect

Adjustment and Corbel cracks and infiltration - other side.

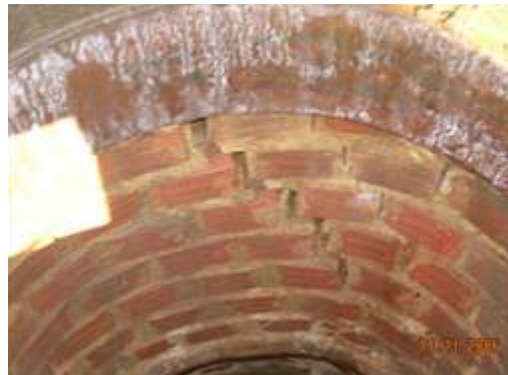
Defect

Adjustment and Corbel cracks and infiltration.

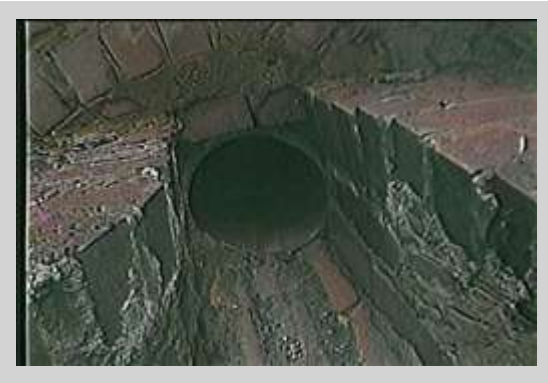
8 in. Circular Gravity Sewer Pipe Out @ 12 O'Clock

Channel deterioration.

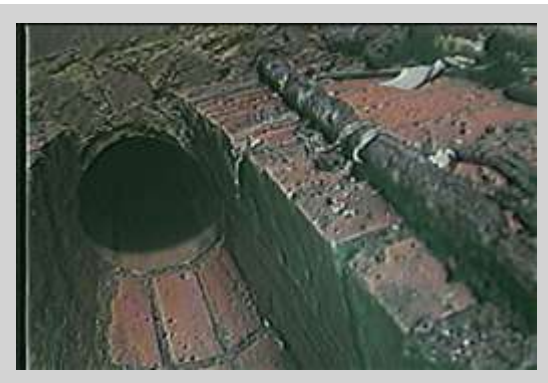
8 in. Circular Gravity Sewer Pipe In @ 3 O'Clock

Barrel deterioration and infiltration.

Infiltration: **Evidence** Pipe Seal Cond: **Unknown**

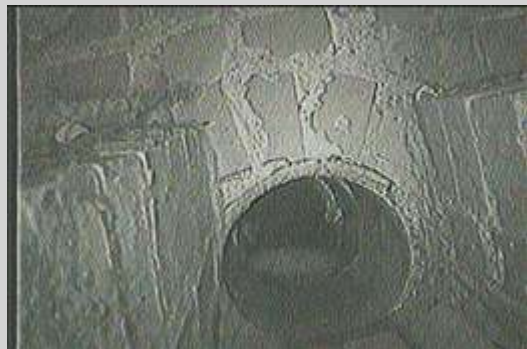
Pipe In @ 9 O'Clock

Infiltration: **Evidence**

Pipe Seal Cond: **Cracked**
